AIR FORCE REUSABLE ROCKET ENGINE PROGRAM

XLR129-P-1

FIRST ANNUAL REPORT

AFRPL-TR-69-3-VOL II

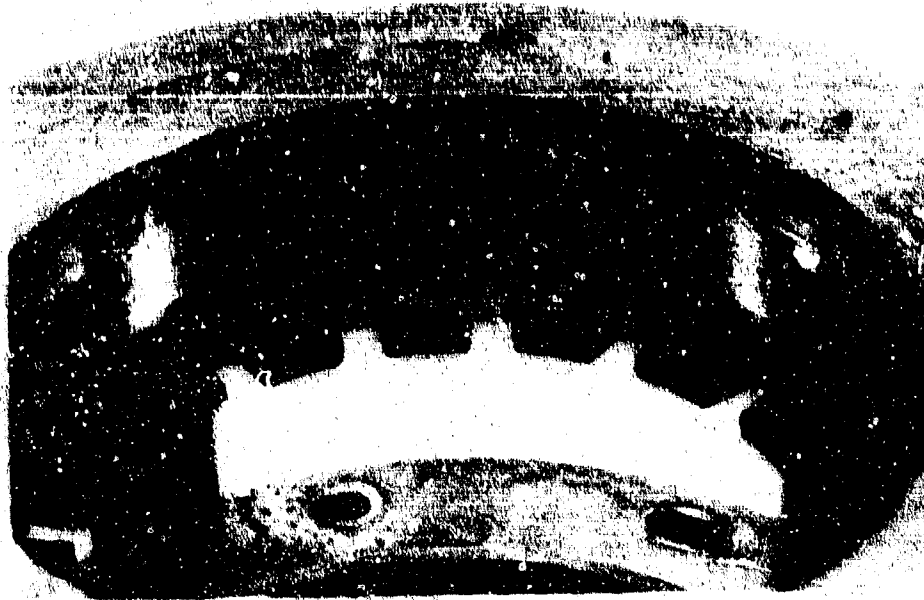
(U) Figure 72. Outer Race Failure in the Unloaded Zone of Load Bearing (S/N X-2) Following Test of Build 25A

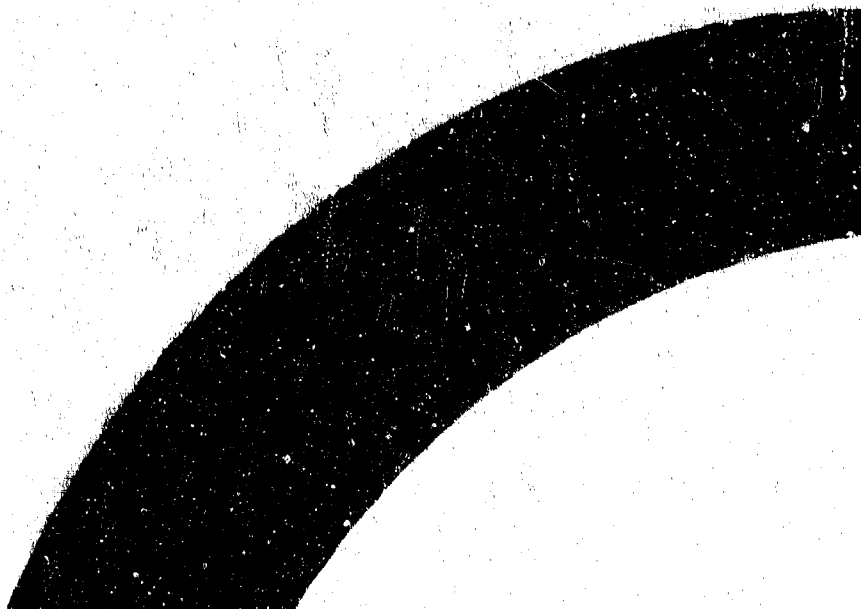
(U) Figure 91. Cracked Outer Race from Reaction Bearing (S/N BB-1) of Build 31

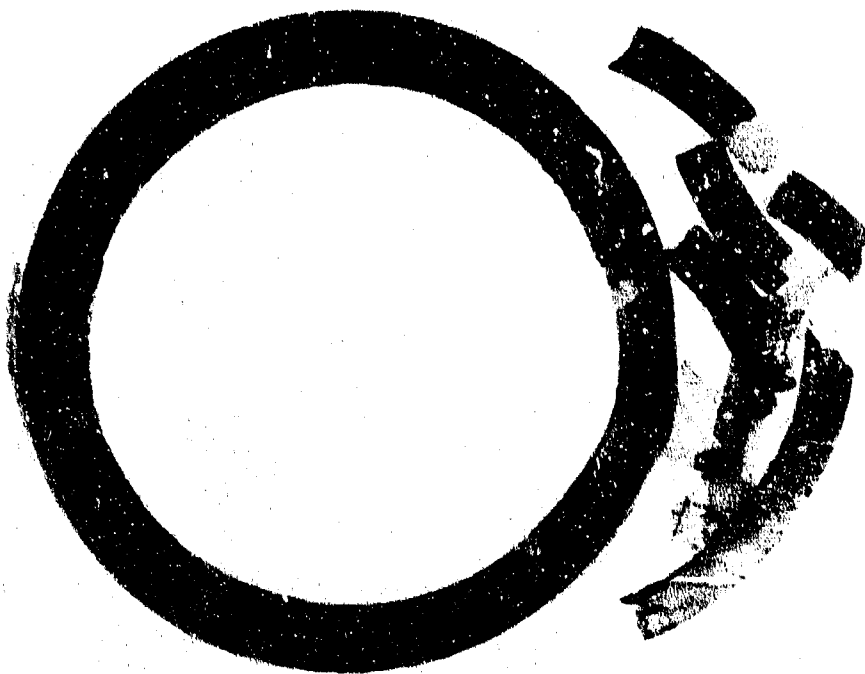
(U) Figure 213. Failed Portion of Disk Seal
After Test

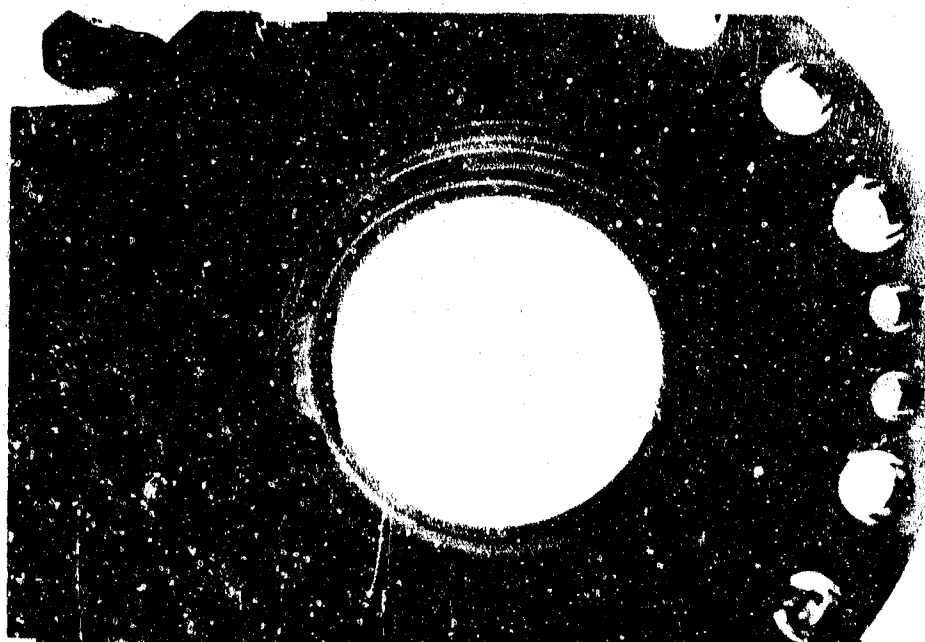
(U) Figure 240. Area of Seal Element Failure
